Technical Report E6357-12
Contract N00039-76-C-0141

WISCONSIN TEST FACILITY
GROUND TERMINAL CORROSION STUDY

April 1978

U. S. Naval Electronic Systems Command
Washington, D. C.

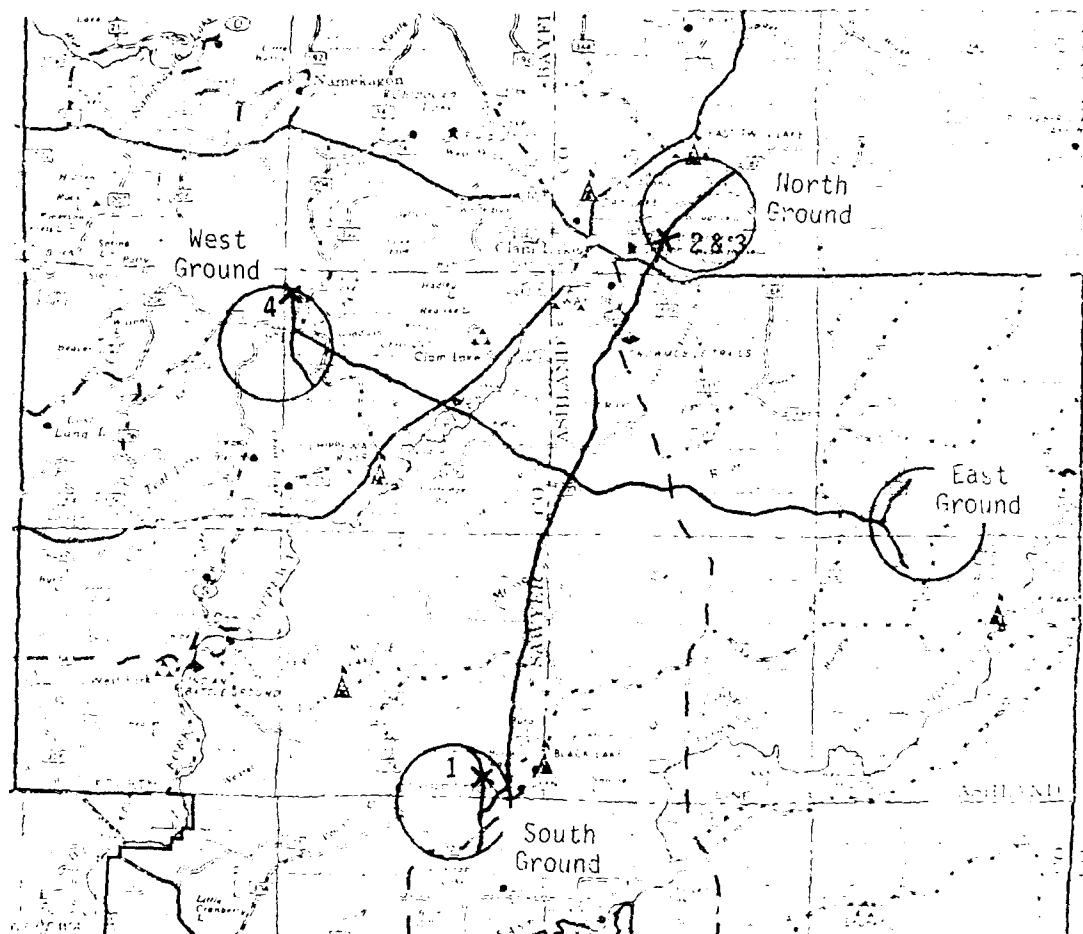
Figure 1 GROUND TERMINAL INSPECTION POINTS AT THE WISCONSIN TEST FACILITY

Each antenna segment at the WTF is connected to the center of a ground terminal as shown in Figure 1. These grounds were located in areas where measurements indicated low near-surface resistivity. This was done to achieve low resistance grounds and to minimize the resulting surface electric fields. Figure 1 also indicates that the north ground partially shares the right-of-way with the North-South antenna segment. The southern half of the north ground terminal was placed in the antenna right-of-way, but the northern half extends beyond the antenna.

During the late summer and early fall of 1977, the Wisconsin Test Facility ground terminals were examined at four different locations, as identified in Figure 1. At each location, after the position of the ground terminal was located using a magnetic field detector, a back-hoe was used to uncover a minimum of eight feet of the ground terminal. A visual inspection of the copper cable was then performed and the diameters of the individual strands of the cable were measured with a vernier caliper. Figures 2 and 3 illustrate typical inspection locations after the ground terminals had been located and exposed.

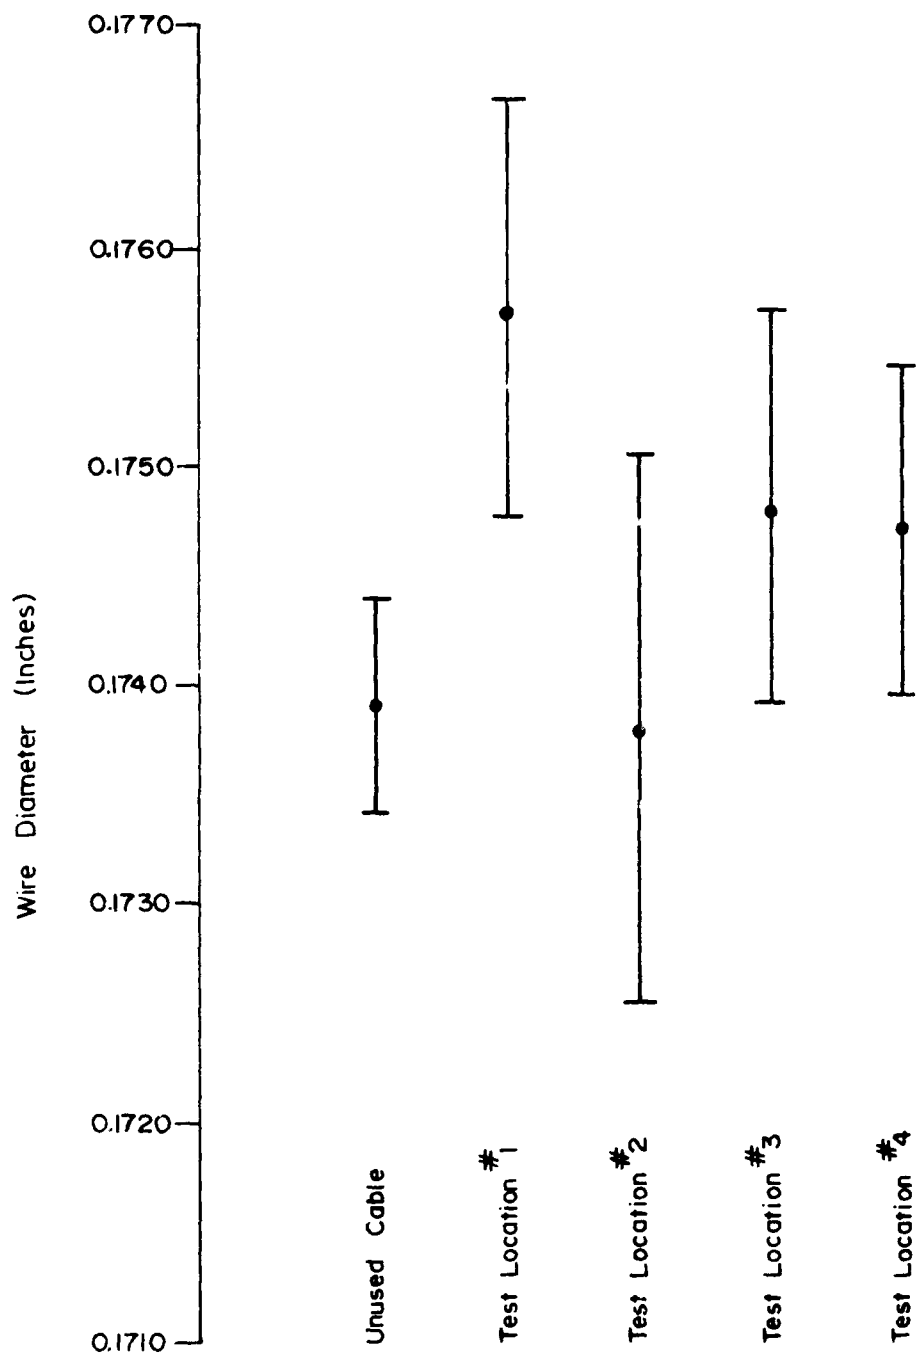
This comparison is shown graphically in Figure 4, which presents both the mean and standard deviation for the ground cable strand diameters at each of the test points and for the control sample. These results indicate that the mean strand diameter of the cable at three of the four test points was slightly greater than that of the control sample.

Fig. 4 MEAN AND STANDARD DEVIATION OF
GROUND CABLE SAMPLE DIAMETERS

At the 99% level of confidence, the t-test shows the difference in mean diameter between Test and Control samples to be statistically significant only at Test Location 1. At the other locations, the sample mean diameters are not different from that of the control sample by a significant amount, according to this statistical test.

The difference in diameter between the control and the sample at Test Location 1 cannot be attributed to corrosion with any confidence, however, since a number of other variables could have produced the observed effect. Some of the factors which could influence the measured wire diameters include: (1) the manufacturing tolerance of the wire ($\pm 1\%$), (2) deformation due to the physical stress of burial and/or excavation, (3) additional deformation due to the separating of the cable to allow measurement of individual strands, (4) the presence of foreign matter on the cable and/or the measurement instrument, and (5) the basic measurement accuracy (± 0.001 inch).

The physical appearance of the cable at all the test points would instead suggest that corrosion is not responsible for the apparent differences in the mean strand diameters. Furthermore, those mean diameters which were determined to be different were always larger than the control sample. It is believed that any corrosive effect would produce a loss of ground cable material and a consequent diameter reduction, rather than the deposition of new material to enlarge the wire. Therefore, although only a limited sampling of ground
